FOURTH QUARTERLY REPORT ON
MANUFACTURING METHODS AND ENGINEERING
FOR TFT ADDRESSED DISPLAY

February 7, 1977 to May 7, 1977

CONTRACT DAAB07-76-C-0027

WESTINGHOUSE INDUSTRIAL AND GOVERNMENT TUBE DIVISION
WESTINGHOUSE CIRCLE
HORSEHEADS, NEW YORK 14845

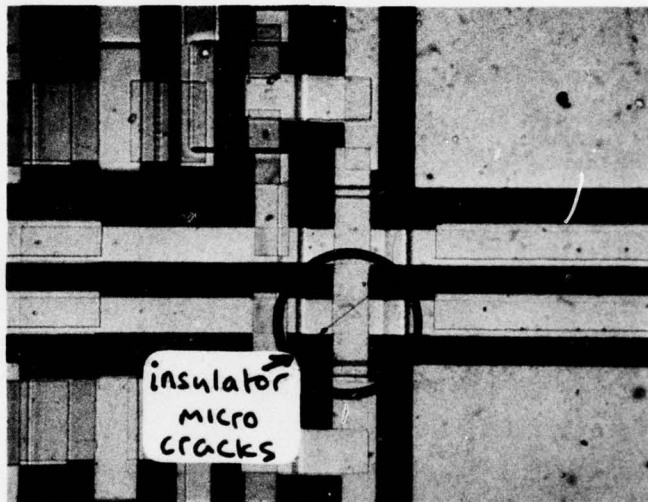
Fig (1) Insulator microcracks

2.2.1 Insulator cracks are a minor but not insignificant problem.

Fig (1) is typical. They cause shorts if they occur between metal deposits in crossover regions. Their cause is as yet not fully pinned down but appears to be related to substrate moisture absorption. The rapid desorption of water when the hot Al_2O_3 nucleates and forms causes a stress condition that strains the film. Either immediately, or possibly during anneal, the cracking occurs. The major question: why is this virtually never observed in the X-Y displays? Several differences are present in the processes viz;

This is a consequence of the logistics of the Super Q water cleaning process and the location of the glass cleaning facility. It could be a factor although Corning 7059 glass should have less "blooming" properties than almost any other glass. Water absorption could occur however in the glass holding and transfer process. We have now ordered another Super Q water facility and will build it into the pilot operation located in proximity to the deposition unit. Meanwhile we will organize the glass transfer to expedite its installation on to the substrate holders and into the vacuum chamber. Dry box transfer will also be tried. All these possibilities are dependent on the assumptions regarding cause. To verify or disprove the role of substrate effects we are now conducting a series of experiments in lab vacuum systems in addition to the above tests in the pilot line itself. Also the possibility of insitu baking of the glass substrates will be investigated. The pilot line is fitted with quartz lamp heaters; initial attempts to use them have been unsuccessful because we use low melting adhesives to keep the substrate from falling off the substrate holders. We do have some suitable substrate holders with edge clips rather than adhesive and these are now being evaluated.

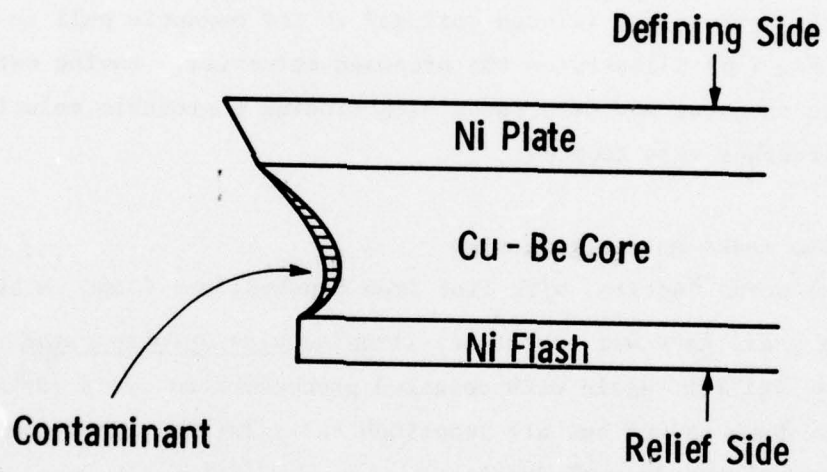
Fig. 4 - Cross section of aperture mask showing lamination groove

and therefore quite delicate. Hence they are not given a physical scrub action. This could be a cause; to establish it we examined a so-called clean Al_2O_3 mask in detail at ultra high magnification. It became obvious that the grooves in the multiple film laminates are contaminated, see Fig (4).

Examination of typical masks revealed an interesting property. The thinner the mask the less indented the laminate groove. This is a consequence of the degree of copper core etch in the first stage of mask fabrication. We tried a set of the thinner masks; the quality level of the circuits was improved. Repeat of the experiment series showed a marked improvement in the edge illuminated contamination test.

We have now standardized on the thinner masks although the mask maker is still proceeding at a rapid pace to fabricate a more conformable kovar set. The circuits made with this thinner set are definitely improved in short quality. See Section 7.

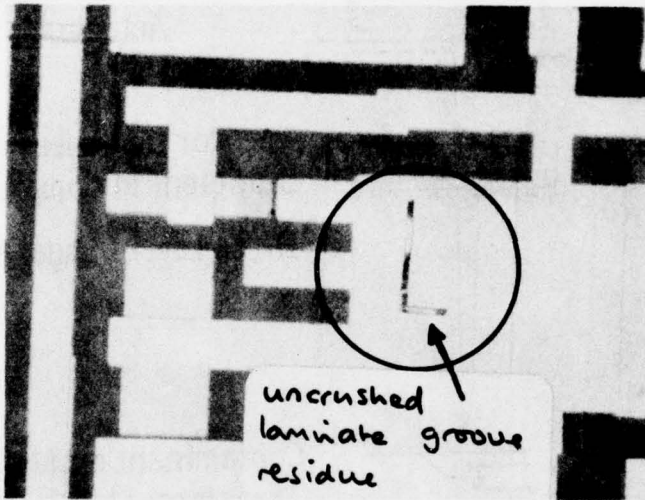
Fig (5) Dislodged contaminant material

Placing glass in contact with the mask transfers this contaminant. Indeed in some cases the entire shaped groove is dislodged, and can be seen on the glass, unbroken as shown in Fig (5). In most cases however the material is quickly mashed to a microparticulate form that is typical of the observed contaminant. Tests indicate that the dislodging of the material occurs when the pneumatic actuator pushes down vigorously (against the release springs) in the magnetic pull up jig action. Fig (6) illustrates the proposed mechanism. Having established a probable cause we now were faced with finding a probable solution. Three approaches were adopted:

- Clean the masks more rigorously.

A physical scrub action, with lint free brushes, was found to be possible providing great care was exercised; likewise heavily attenuated ultrasonics was utilized again with detailed procedures to avoid mask damage. These have been useful but are laborious and relatively dangerous procedures as regards mask damage.

- Obtain masks having no laminates.

The mask supplier fabricated a mask set for us made completely from kovar. This avoids any lamination and should make the mask easier to clean. In addition the kovar mask would be more magnetic, and have better thermal properties. Although the masks were of sufficient tolerance precision, it was found that they were too stiff to operate in the magnetic pull up jig. They did not "conform" sufficiently. An order has been now placed for less stiff masks.

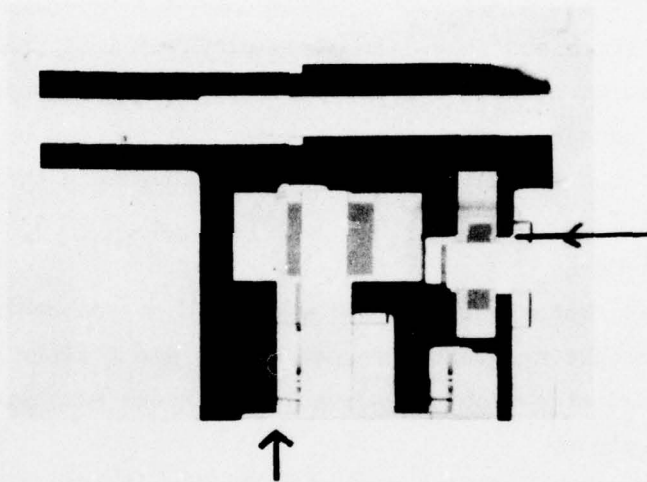
Fig (7) Gate alignment problem

A creeping problem in recent weeks was pattern alignment; this had been generally satisfactory but started to drift off on a patchy, irregular, basis. In particular gate alignment over the corner to corner areas deteriorated. See Fig (7). Several causes were tracked down. Firstly it was thought that mask to mask pattern integrity was perhaps being lost due to the mixing up of mask sets as a consequence of the change in mask thickness as described in Section 2.3 above. The masks are however "pulled" from the same master and, although the mask metal thickness does have a slight effect, tests on the alignment registration system proved this to be wrong. Another

possibility lay in the mask clamping.

It is difficult to reproduce the same tension on the mask holder clamps and in addition a degree of uncertainty was found to exist as to whether it was useful to tighten down both sides of the mask. When this was cleared up the problem still remained. Recently (Run 192, see Table (1) Section 7) the cause was pinned down pretty well definitively -- the teflon bushings on the master alignment jig were slightly worn! The bushings were replaced and to date four out of five circuits have been good in this respect, the one poor sample being an error.

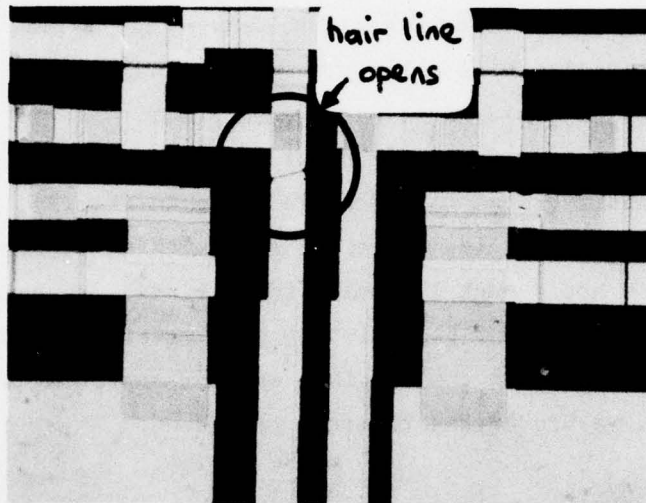
Fig (8) Hair line opens in busbars

One category of opens is "hair lines", Fig (8) illustrates this phenomena which occurs rarely but sufficiently often to cause problems. Fine opens ($\sim 0.2 \mu\text{m}$ in width) cut across circuit segments almost always in metal films although it is likely that they are most visible in metals and much less so in the transparent insulators. These lines characteristically cut busbars and are not found in adjacent pads but then can be seen in other adjacent segments.

This is characteristic of mask contamination once again. The segments broken correspond to the pattern segments on the same mask.

Lint is a possible contender but we are familiar with lint and related fibers and they are not so thin or smooth in appearance. Fine glass hair line defects are likely although the selective nature of the problem is hard to explain on that basis. An alternate glass substrate with much improved surface texture has been recommended by

The most likely possibility, given the shape and appearance of this fine line, is a fine trace of DUCO^(R) cement that has contaminated a mask. This is consistent with the evidence. DUCO is not used in the X-Y system and this problem is not found in the X-Y system. DUCO is almost impossible to see on the mask when it is this fine. DUCO burns out clean during anneal to give a clear line as is found. The DUCO is used as a back up adhesive to ensure the substrate does not fall off. Another technique, with double stick kapton tape is now being evaluated. This also will allow the insitu glass prebake that we are trying in order to avoid glass water adsorption.

Corning; this is low alkali as is the present glass. We have ordered this glass, however it is a long shot.

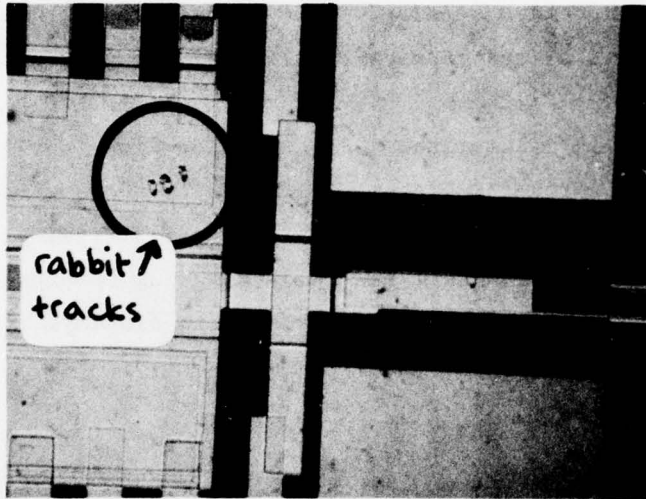
Fig (9) Rabbit tracks

A minor additional source of occasional opens (and sometimes shorts) is "rabbit tracks". These are shown in Fig (9), although this is an extreme example. The effect is a scratching of the films in small localized areas much like tiny foot prints. We believe that these are caused by abrasion of the films by mask metal asperities. The mask asperities are either in the original mask or appear as a result of mask clearing, we are trying to track this down.

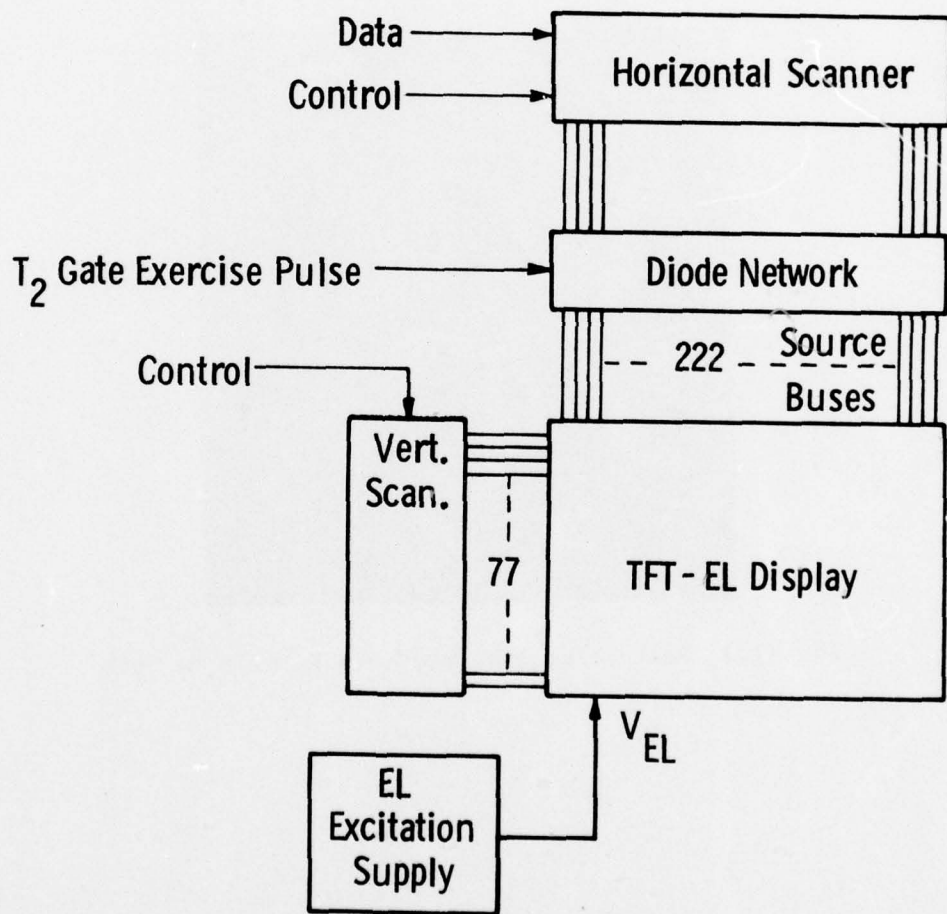
Fig. 10 - Alternate address scheme

The only question is the dc gate negative (off T_2) condition. If the device threshold is too negative it needs V_{GS} too negative for good long term stability. Various tests for this type of stability are being checked now; it has already been established that the doping of the TFT gap described last quarter improves this property.

address scheme so that the T_2 gates are not under a continuous V_{GS} negative condition has been developed; an outline schematic is shown in Fig (10). This address scheme is one answer; a better one is to ensure that the devices are made with the threshold close enough to $V_{GS=0}$ to avoid the need for large offset gate bias levels.

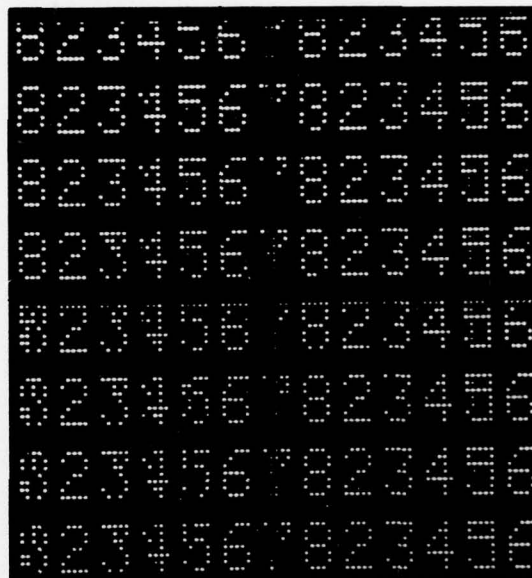
Fig (11) Best pilot line produced display to date

Fig (11) illustrates the best pilot line fabricated display to date. Some further improvement in circuit opens will certainly bring the displays up to the quality of the X-Y displays. Following the guidelines detailed here and hence clearing up these minor but troublesome detail problems should result in displays of a defect level exceeding the best made to date.

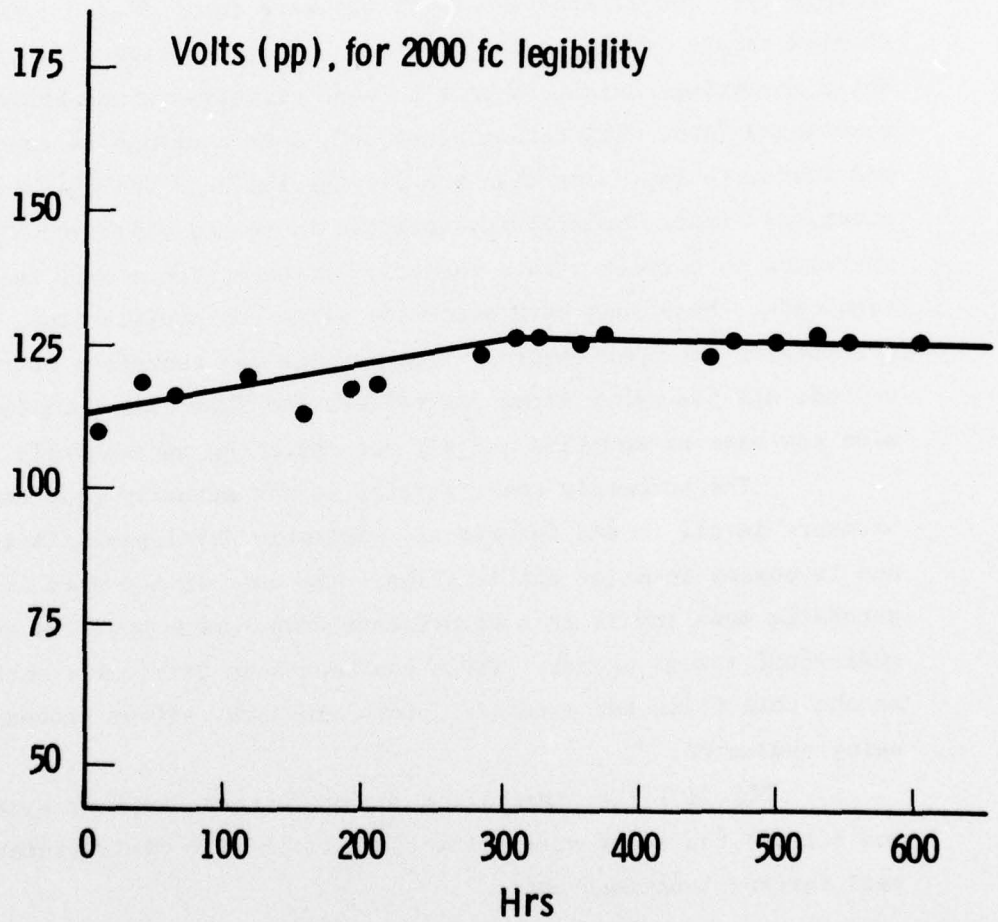
Fig. 12 - Constant brightness life test, 600 hrs
at 2000 fc legibility level

A 600 hrs life test has been set up and run under conditions identical to that required by SCS 501, except that for this initial run the display was maintained at room temperature. The entire panel is exercised (every element), the gates are scanned and the sources held at constant voltage. The EL voltage was set at a value to give 2000 fc legibility. The panel was set at 50 mins ON 10 mins OFF. Bias settings, defect counts, brightness and power dissipation were measured before and after the test. The results are shown in the attached Fig (12). Initial dissipated power - all elements on, 853 MW. Final dissipated power - all elements on 980 MW, within specifications.

No ON elements turned off and only ~2 off elements turned on. A few (~7) new shorts appeared.
